PAINTING MATERIALS INVESTIGATION FROM DRAGU WOODEN CHURCH, SALAJ COUNTY

ABSTRACT. The old wooden church from Dragu, Sălaj County, was built on the hill of Dragu village between 1806 and 1809, according to the inscription found inside. The investigations targeted the imperial gates (the main entry from the nave to the altar used by the priest during church service and adorned with painted icons and elaborated wood sculpture) and aimed to identify the materials used for their manufacture: the wood species, pigments, ground, binders. For the identification of materials two spectroscopic methods were employed: XRF (X-ray fluorescence) and FTIR (Fourier transform IR absorption). The employed materials are: linden wood for the imperial gates, gypsum for ground; lead white, Prussian blue, gold and silver leaf, iron red, lead red, cinnabar, realgar, orpiment, Scheele's green for pigments; egg yolk and bone glue as binders.

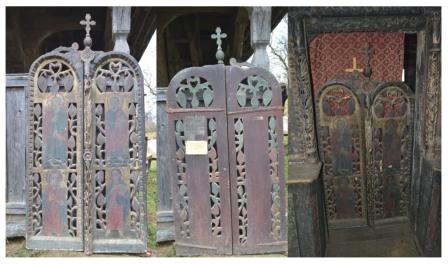
Figure 3. Imperial Gates (front and back)

The imperial gates, see Fig. 3, are made from a carved piece of wood with frames on the edges and the two icons inside each. The painter made only four icons representing the four evangelists, giving up the icon of the Annunciation probably due to lack of space or material.

According to the inscription on the back side, the imperial gates were made and painted in 1816.
